**Study of the damage caused to
the red brick buildings (Qena wall) in
the Golden Triangle area in Egypt
and the proposed treatment plan**

**Conservation department, Faculty of Archaeology, South
Valley Univ., Qena, Egypt, 83523**

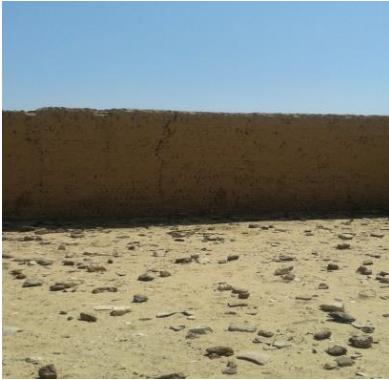
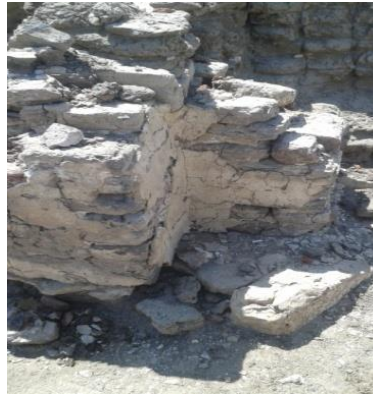
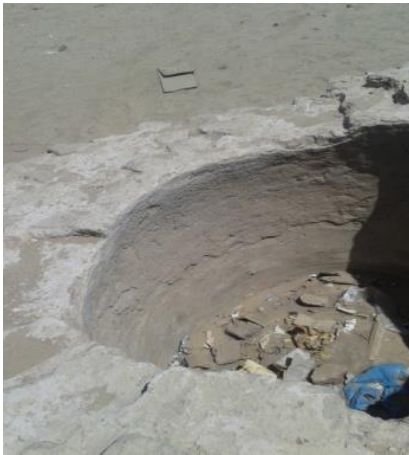
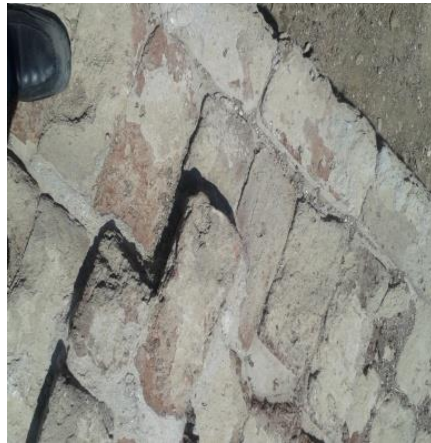
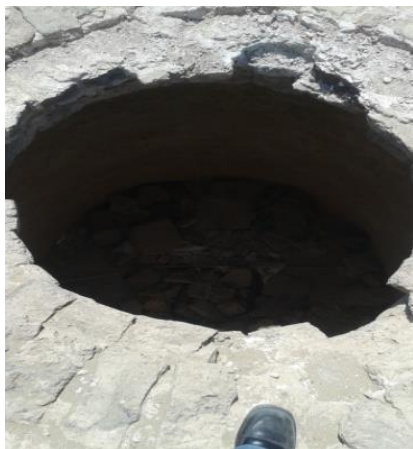
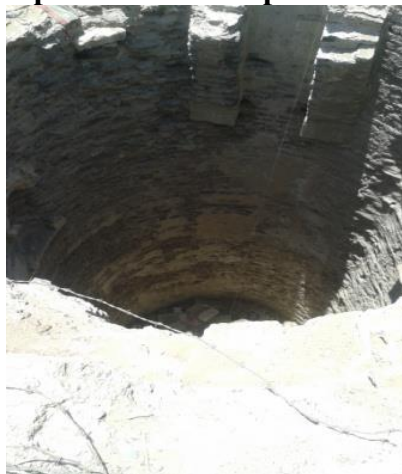
Fig.2 showing the red bricks from which the walls and wells are built in the study site and it shows the loss of parts of the bricks, in addition to the weak cohesion of the brick components and the appearance of some cracks and salts.

During field observations of the red bricks of the wells under study, many signs of damage were found. Fig. 2. It shows some more decomposition, such as discoloration of red bricks (a, b); efflorescence salts especially in the lower regions (d); the presence of some droppings of insects, reptiles and rodents (e); the presence of cracks in the surface crust of red bricks (d); The mortar compounds decomposed between the bricks (c and d), and some parts of the bricks turned into powder (c); partial and complete collapse and weakening of the brick structure (a and b); Sharp edges and semicircular corners are eroded by bricks (b); Numerous pits in the bricks (d), the presence of previous effects of water and moisture, which may have been caused by rain or torrential rains scattered in the area (c); Brick roofs are given sintered layers of earth and sand tipped in area (c); Partial collapse of some parts of the red brick (b, c) and the presence of bird and insect nests on the roofs of the red brick (c). This led to the brick losing its aesthetic shape and was seriously affected by many decay factors that had an important role in the deterioration of the red brick walls. Micrographs of the thin section of brick samples taken for study by PLM. Fig. 3, This is explained by the presence of a coarse texture containing large grains of abortive dyed with iron oxides. Calcium silicate minerals (C) can be observed. (e) The microstructure resulting from the presence of the newly formed abortive clusters; (f) Presence of reunite and edit as non-essential minerals, bricks show small cracks and cracks, resulted of presence of apatite and tourmaline, which leads to increased secondary porosity.

Consolidation of weak brick units using suitable water-resistant materials such as ethyl silicate (TEOS), It also provides protection from sodium sulfate, to re-install the separated brick blocks, wholly or partially, lime mortars can be used from the same site with the addition of primal to improve its mechanical properties. The mechanical removal of dry biological residues is also must be removed, and chemical pesticides can be used to remove it, and prevent its future growth. In addition, titanium dioxide (TiO₂) nano-coating can be used to prevent the growth of microorganisms on the bricks, with periodic and continuous monitoring of the bricks to notice any changes in them ^{xxvii}. Before starting cleaning work, the goal or purpose of cleaning is determined first, as there are many important reasons for cleaning brick surfaces in order to reveal and highlight the aesthetic values of bricks, and cleaning is a necessary work in restoration. Cleaning here means removing harmful components from surfaces such as water-soluble salts and many contaminants. Cleaning is also an important step in preparing the surface for consolidation if needed ^{xxviii}.

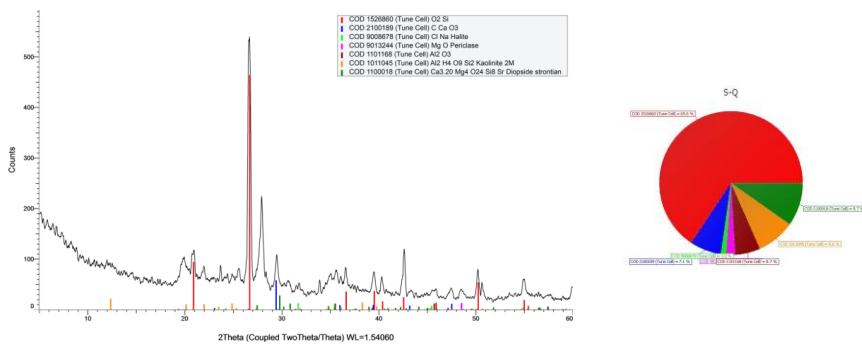
XRD analyses of the bricks reveal that: The Mineral composition of the whole sample of the ancient brick

includes: Silicon dioxide SiO_2 calcium carbonate CaCO_3 sodium chloride NaCl , Magnesium oxide MgO periclase, Kaolinite, Diopside, Feldspar, Prehnite, Apatite, Tourmaline, Anorthite,], dolomite, tridymite, illite, mullite. the refined unit cell dimensions and volume of quartz constituting the main content of this sample are typically the same of those of the theoretical one fig. 4.

XRD analyses of the bricks reveal that: The Mineral composition of the whole sample of the ancient brick includes: fig.4. a,b and c. showed that bricks consist of Silicon dioxide SiO_2 [65.5% - 77.1- 29.2], calcium carbonate CaCO_3 [7.1 - 8.0- 2.8%], sodium chloride NaCl [1.2- 0.9- 1.0%], Magnesium oxide MgO periclase [1.2- 1.1- 1.6%], Kaolinite [8.6- 8.2 - 5.7%], Diopside [9.7- 4.6%], Feldspar[5.9%], Prehnite [4.5%], Apatite[3.4%], Tourmaline [8. %7], Anorthite [36.1%], Hematite [1.1%], fig.4.d. showed that quartz [32.1%], feldspars [31.8%], dolomite [9.6%], tridymite [6.5%), illite [5.6%], mullite [5.3 %].
